CSX Transportation Inc.
Underwater Inspection of Structures in the Northeast Region

2008 UNDERWATER BRIDGE INSPECTION REPORT

**Bridge No. CA 26.4 over Lee Hall Reservoir
Including Weir and Stone Embankment
Newport News, Virginia**

Inspection Date: July 9, 2008

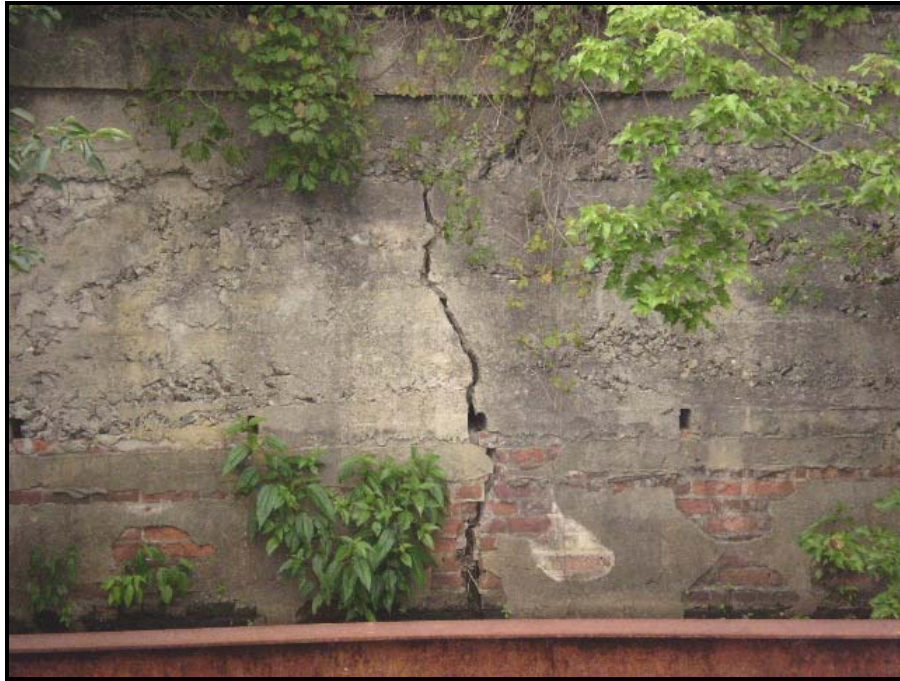
Photo 7
Vertical Crack in North Headwall, Also Note Heavy Honeycombing

Description	Priority
1. Seal the cracks in the North Headwall and the culvert with epoxy.	Medium
2. Stabilize the South Wingwalls.	High

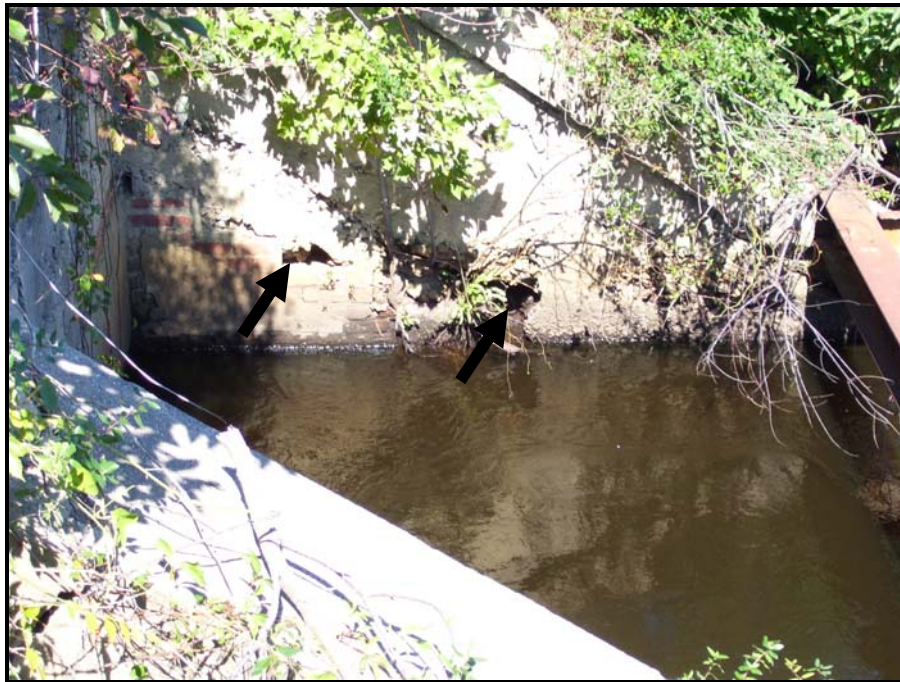
Photo 8
Voids in Northwest Wingwall at Masonry to Concrete Transition

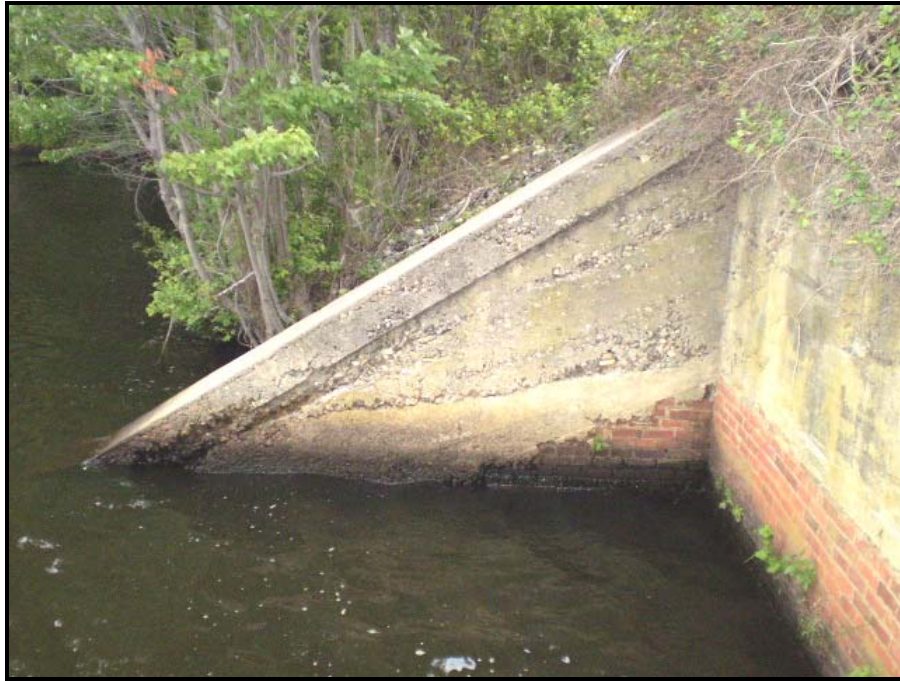
Photo 9
Elevation of Southwest Wingwall, Note Heavy Honeycombing

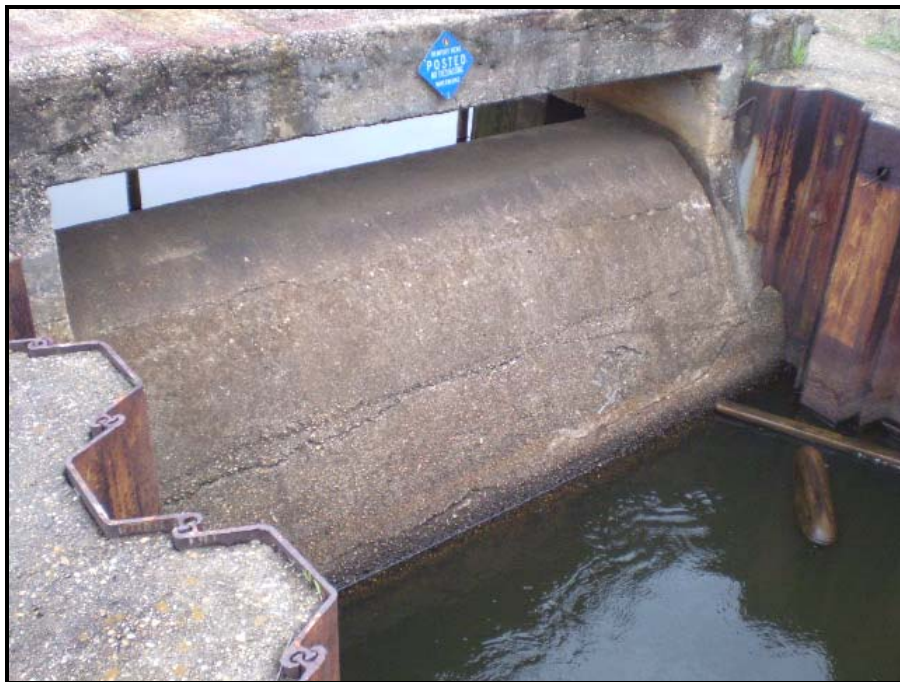
Photo 10
South Elevation of Concrete Weir Wall (Note Scale Throughout)

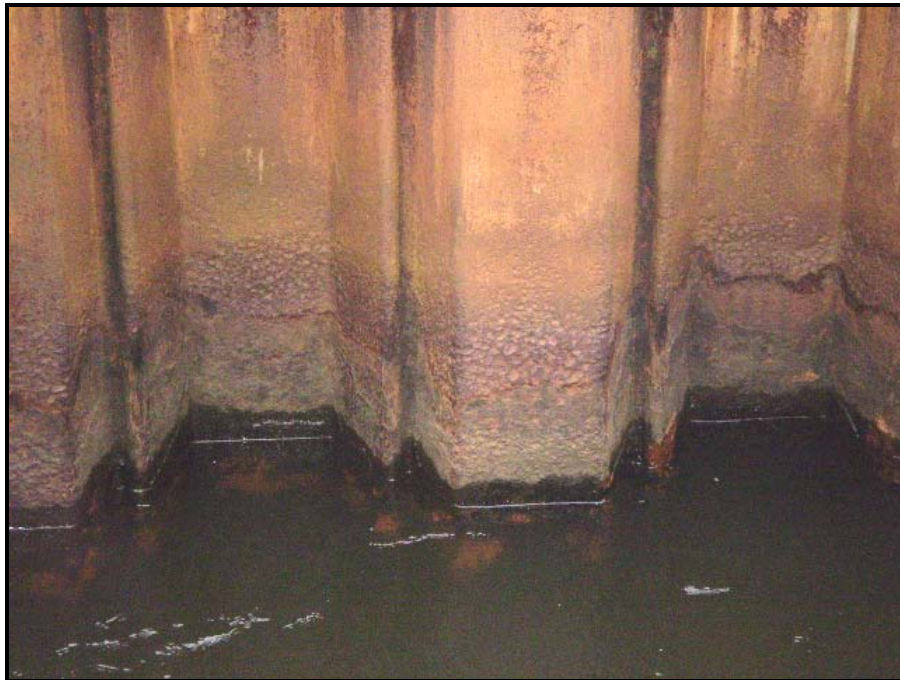
Photo 12
Typical Pitting at Waterline in Steel Sheet Pile Weir Wall

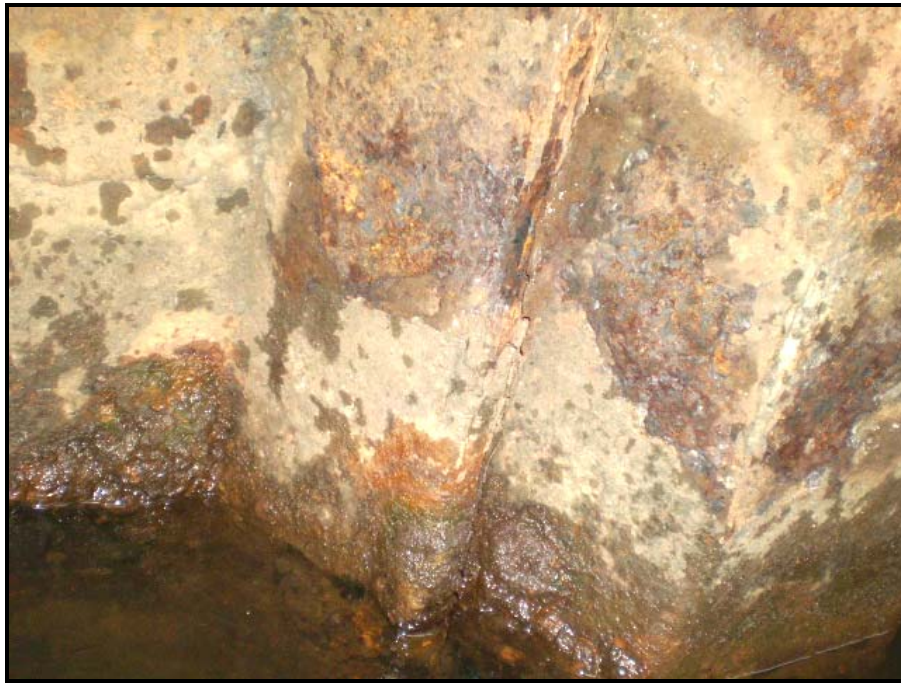
Photo 13
Typical Pitting at Waterline in Steel Sheet Pile Weir Wall

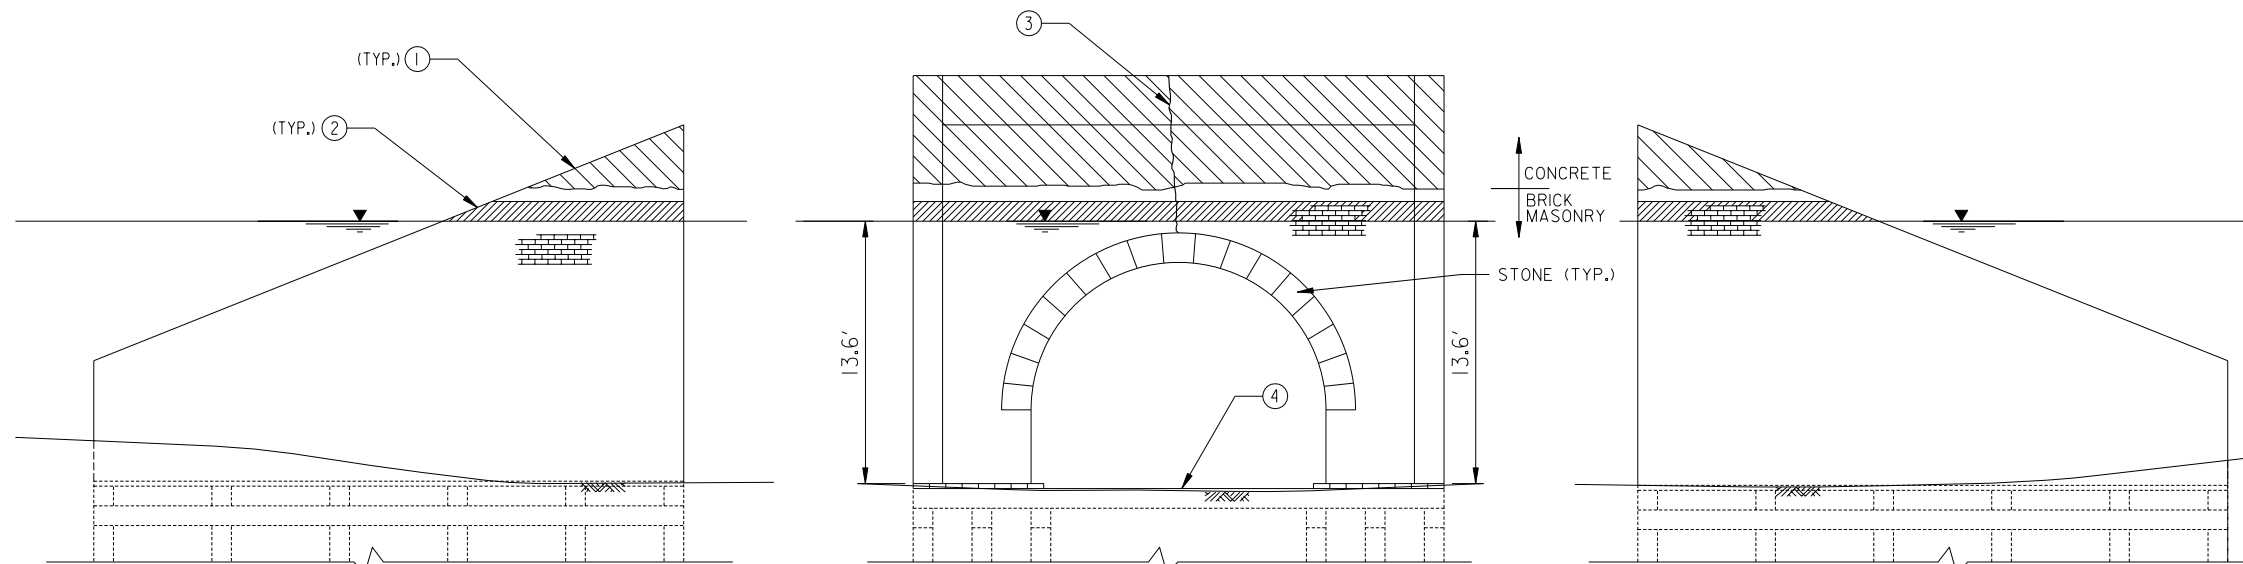
INSPECTION FINDINGS - NORTH HEADWALL AND NORTH WINGWALLS

NORTH HEADWALL CONDITION RATING IS 4 - POOR.
 NORTH WINGWALLS CONDITION RATING IS 4 - POOR.

- ① HONEYCOMBING UP TO 2" DEEP ALONG POUR JOINTS. CONCRETE CAN BE REMOVED BY HAND.
- ② 100% LOSS OF MORTAR IN A 1' HIGH BAND AT THE HIGH WATERLINE.
- ③ VERTICAL CRACK UP TO 2 1/2" WIDE EXTENDING FROM TOP OF CAP TO TOP OF VOUSSOIR STONES. CRACK IS WIDEST AT BOTTOM.
- ④ LESS THAN 5% OF 3X10 LONGITUDINAL TIMBER PLANKS REMAIN INSIDE OF THE CULVERT.

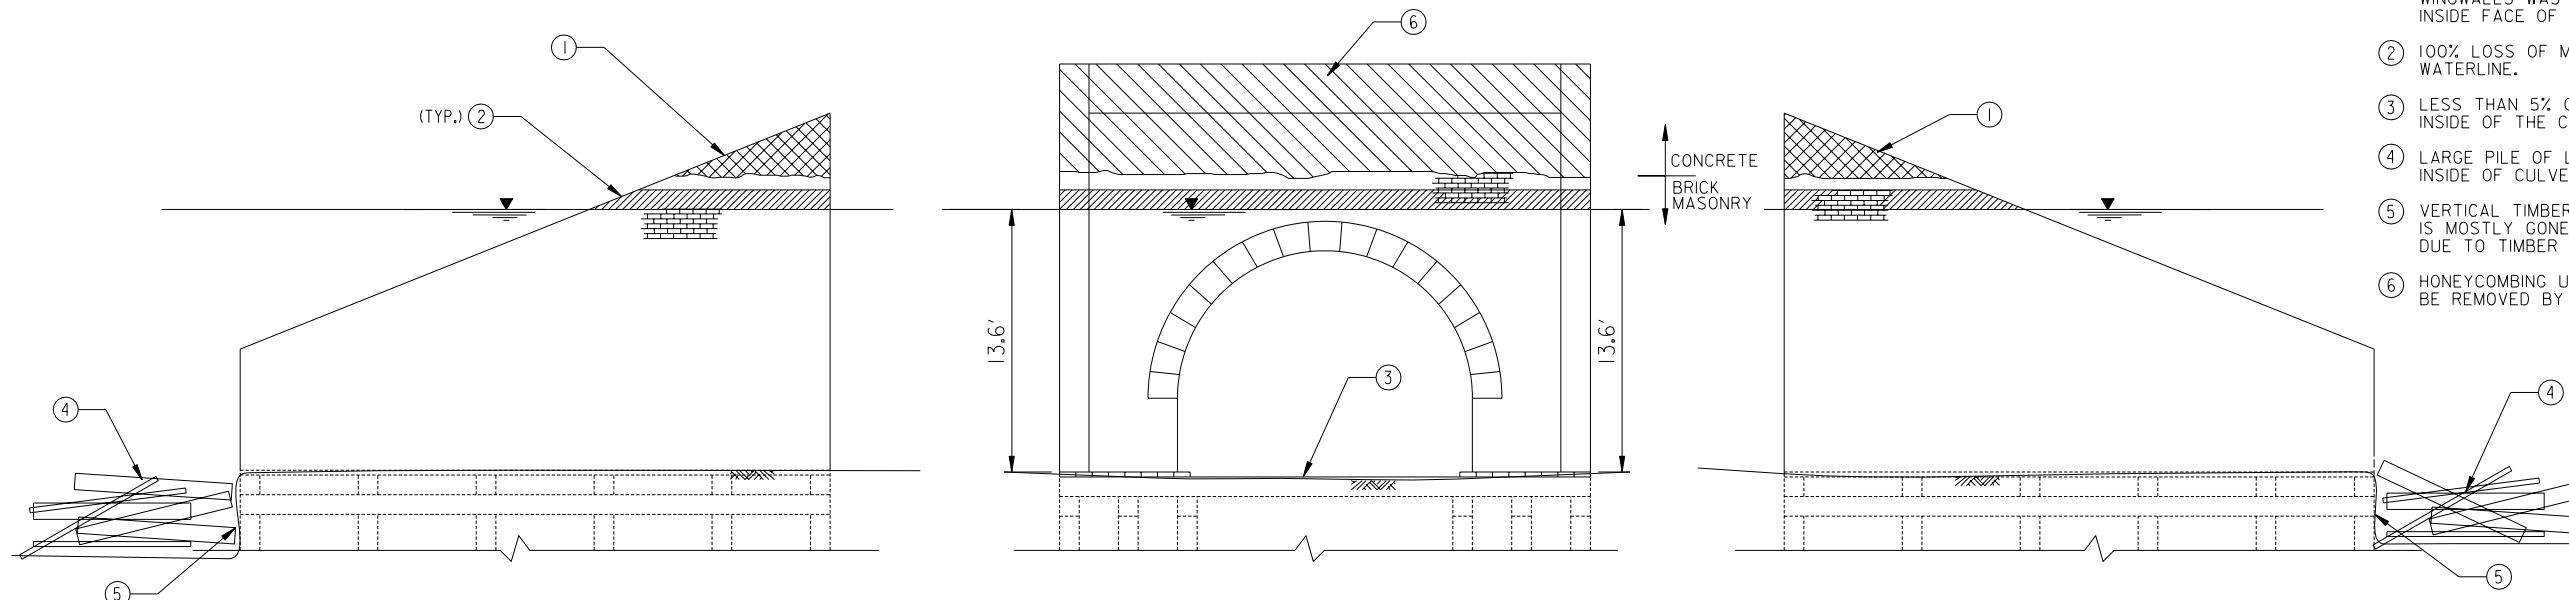
INSPECTION FINDINGS - SOUTH HEADWALL AND SOUTH WINGWALLS

SOUTH HEADWALL CONDITION RATING IS 6 - SATISFACTORY.
 SOUTH WINGWALLS' CONDITION RATING IS 2 - CRITICAL.

- ① HONEYCOMBING UP TO 4" DEEP ON INSIDE FACE OF WINGWALLS AND UP TO 6" DEEP ON OUTSIDE FACE OF WINGWALLS ALONG POUR JOINTS. CONCRETE CAN BE REMOVED BY HAND. CONCRETE PORTION OF WINGWALLS WAS BUILT TO OVERHANG THE BRICK MASONRY ON THE INSIDE FACE OF THE WINGWALLS.
- ② 100% LOSS OF MORTAR IN A 1' HIGH BAND AT THE HIGH WATERLINE.
- ③ LESS THAN 5% OF 3X10 LONGITUDINAL TIMBER PLANKS REMAIN INSIDE OF THE CULVERT.
- ④ LARGE PILE OF LOOSE 3X10 TIMBER PLANKS FROM TIMBER DECKING INSIDE OF CULVERT.
- ⑤ VERTICAL TIMBER SHEETING AT SOUTH END OF TIMBER SUBSTRUCTURE IS MOSTLY GONE. TIMBER SUBSTRUCTURE COULD NOT BE ACCESSED DUE TO TIMBER DEBRIS.
- ⑥ HONEYCOMBING UP TO 2" DEEP ALONG POUR JOINTS. CONCRETE CAN BE REMOVED BY HAND.

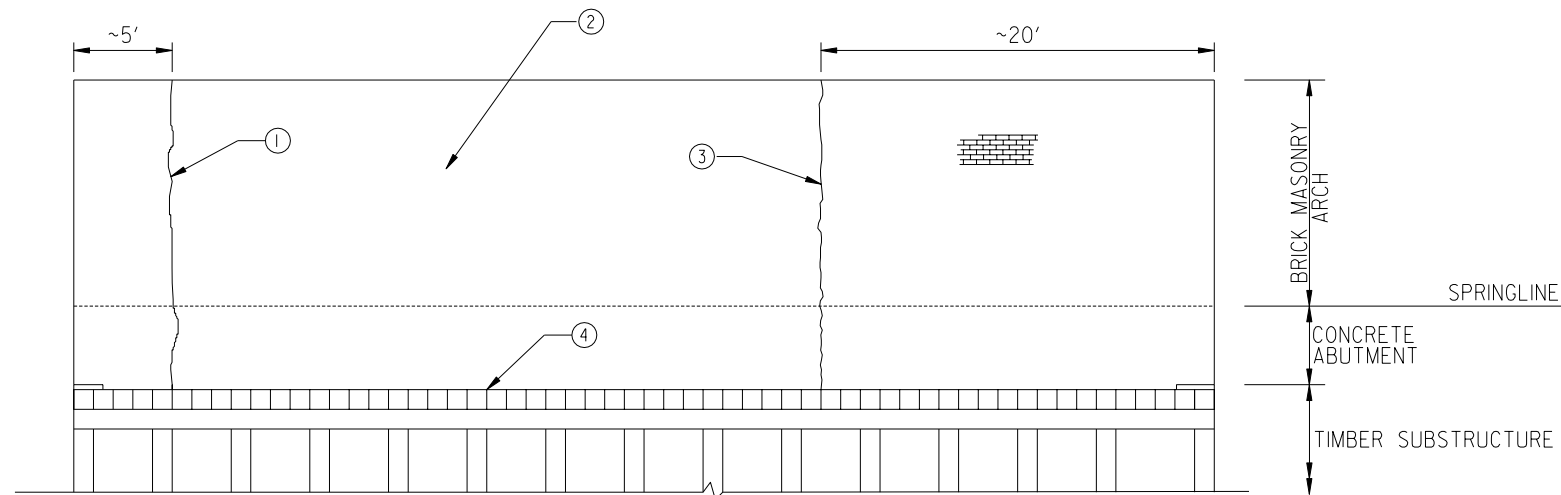
INSPECTION FINDINGS - WEST ABUTMENT

WEST ABUTMENT CONDITION RATING IS
6 - SATISFACTORY.

- ① FULL HEIGHT CRACK 2" WIDE AT TOP OF CULVERT ARCH IN THE BRICK MASONRY AND 1" WIDE AT THE BOTTOM OF BOTH ABUTMENTS.
- ② BRICK MASONRY INTRADOS IN GOOD CONDITION WITH VERY LITTLE LOSS OF MORTAR.
- ③ FULL HEIGHT CRACK 4" WIDE AT TOP OF CULVERT ARCH IN THE BRICK MASONRY AND 1" WIDE AT THE BOTTOM OF BOTH ABUTMENTS.
- ④ LESS THAN 5% OF THE LONGITUDINAL TIMBER 3X10 PLANKS REMAIN INSIDE OF THE CULVERT.

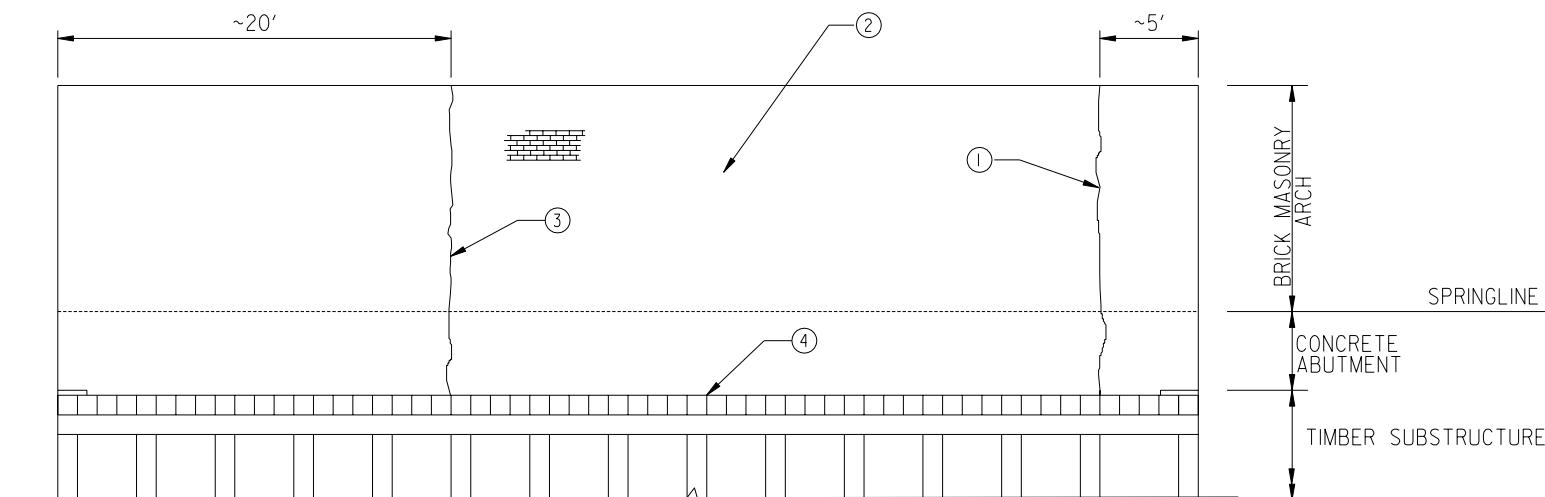
INSPECTION FINDINGS - EAST ABUTMENT

EAST ABUTMENT CONDITION RATING IS
6 - SATISFACTORY.

- ① FULL HEIGHT CRACK 2" WIDE AT TOP OF CULVERT ARCH IN THE BRICK MASONRY AND 1" WIDE AT THE BOTTOM OF BOTH ABUTMENTS.
- ② BRICK MASONRY INTRADOS IN GOOD CONDITION WITH VERY LITTLE LOSS OF MORTAR.
- ③ FULL HEIGHT CRACK 4" WIDE AT TOP OF CULVERT ARCH IN THE BRICK MASONRY AND 1" WIDE AT THE BOTTOM OF BOTH ABUTMENTS.
- ④ LESS THAN 5% OF THE LONGITUDINAL TIMBER 3X10 PLANKS REMAIN INSIDE OF THE CULVERT.

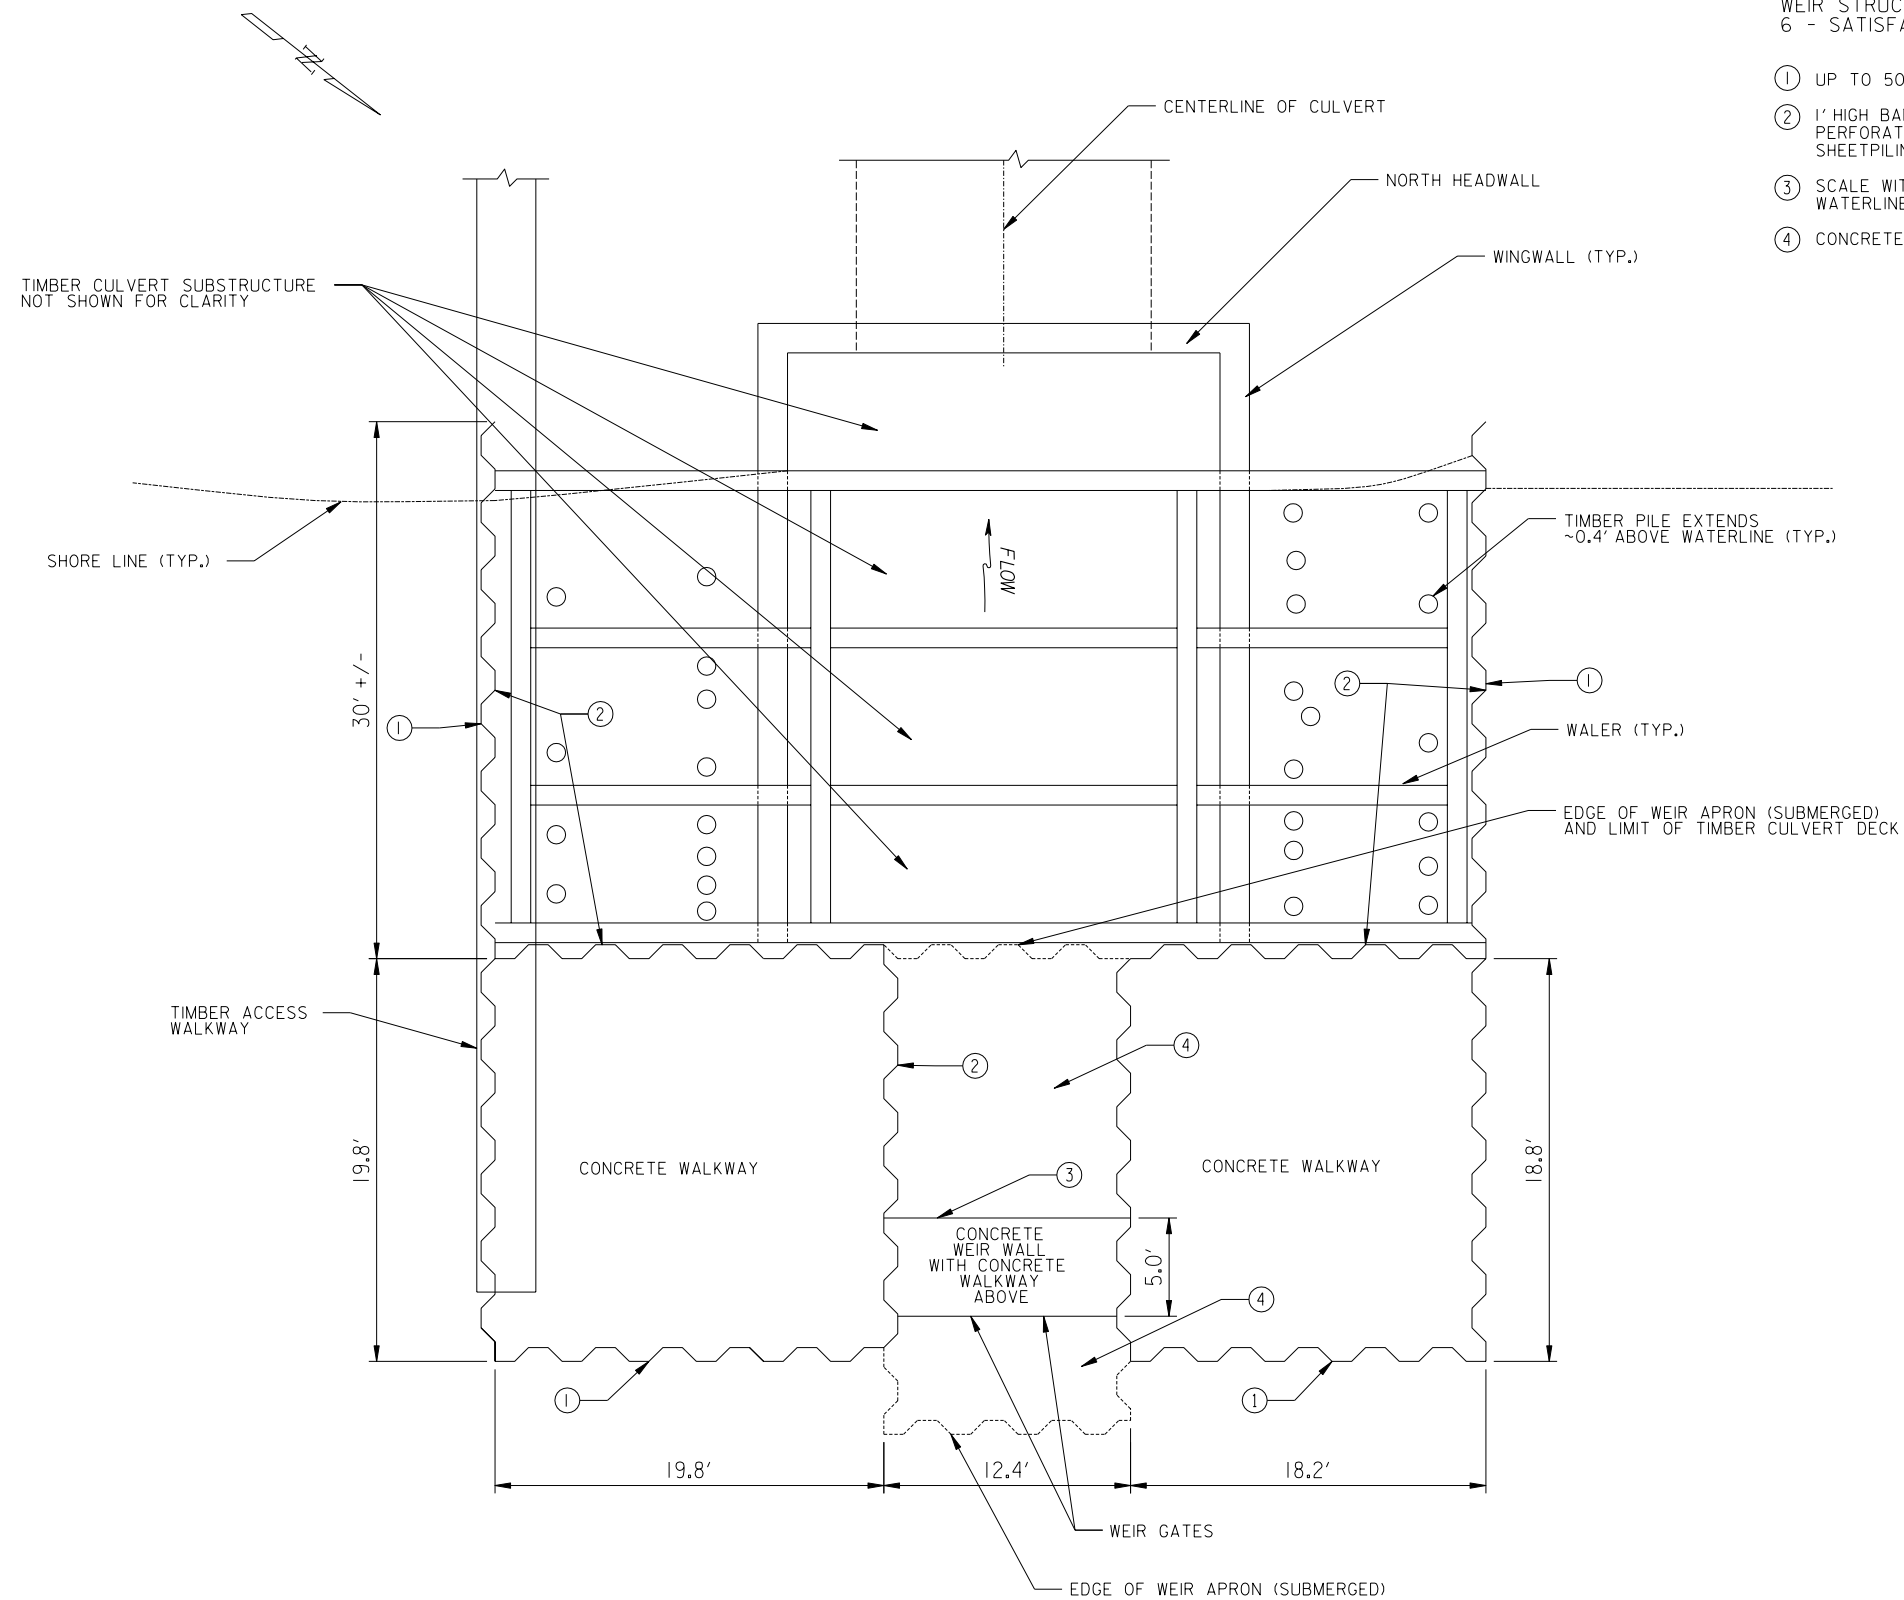
INSPECTION FINDINGS - WEIR STRUCTURE

WEIR STRUCTURE CONDITION RATING IS
6 - SATISFACTORY.

- ① UP TO 50% SECTION LOSS THROUGHOUT THE OUTSIDE FACE OF THE STEEL SHEETPIILING.
- ② 1' HIGH BAND OF 60-70% SECTION LOSS AT THE HIGH WATERLINE WITH SOME NEAR PERFORATIONS. UP TO 50% SECTION LOSS ELSEWHERE ON INSIDE FACE OF THE STEEL SHEETPIILING.
- ③ SCALE WITH EXPOSED LARGE AGGREGATE FROM 1' ABOVE THE HIGH WATERLINE TO THE WATERLINE ON THE WEIR WALL.
- ④ CONCRETE INVERT AND APRON OF WEIR ROUGHLY POURED.
