CSX Transportation Inc.
Underwater Inspection of Structures in the Northeast Region

2008 UNDERWATER BRIDGE INSPECTION REPORT

**Bridge No. CA 26.4 over Lee Hall Reservoir
Including Weir and Stone Embankment
Newport News, Virginia**

Inspection Date: July 9, 2008

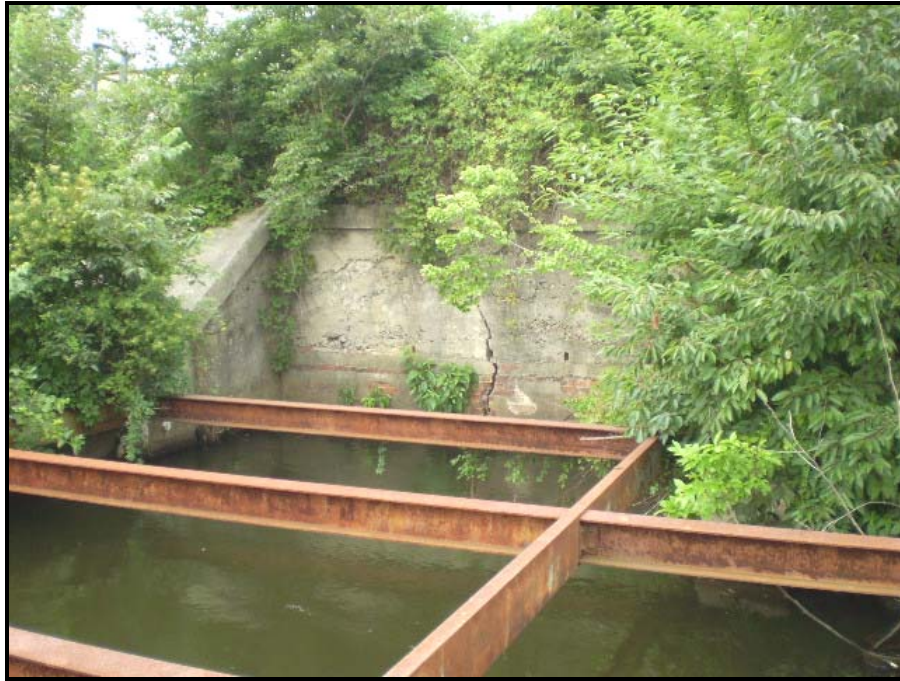
Photo 1
North (Upstream) Headwall

The culvert headwalls and wingwalls are in satisfactory to critical condition. Both headwalls and the North Wingwalls exhibit honeycombing up to 2" deep with exposed large aggregate along the pour joints. The South Wingwalls exhibit honeycombing up to 4" deep on the inside face and up to 6" deep on the outside faces along the pour joints. The concrete along the pour joints can be removed by hand on both headwalls and all of the wingwalls. The South Wingwalls were built to overhang the brick masonry below. This, combined with the extensive section loss due to honeycombing, has compromised the stability of the wingwalls. There is a vertical crack up to 2 1/2" wide in the North Headwall extending from the top of the cap to the top of the voussoir stones. The crack is widest at the bottom. A 1' high band of missing mortar exists at the waterline throughout both headwalls and all of the wingwalls.

NORTH HEADWALL CONDITION RATING IS 4 - POOR.
 NORTH WINGWALLS CONDITION RATING IS 4 - POOR.

- ① HONEYCOMBING UP TO 2" DEEP ALONG POUR JOINTS. CONCRETE CAN BE REMOVED BY HAND.
- ② 100% LOSS OF MORTAR IN A 1' HIGH BAND AT THE HIGH WATERLINE.
- ③ VERTICAL CRACK UP TO 2 1/2" WIDE EXTENDING FROM TOP OF CAP TO TOP OF VOUSSOIR STONES. CRACK IS WIDEST AT BOTTOM.
- ④ LESS THAN 5% OF 3X10 LONGITUDINAL TIMBER PLANKS REMAIN INSIDE OF THE CULVERT.

Description	Priority
1. Seal the cracks in the North Headwall and the culvert with epoxy.	Medium
2. Stabilize the South Wingwalls.	High

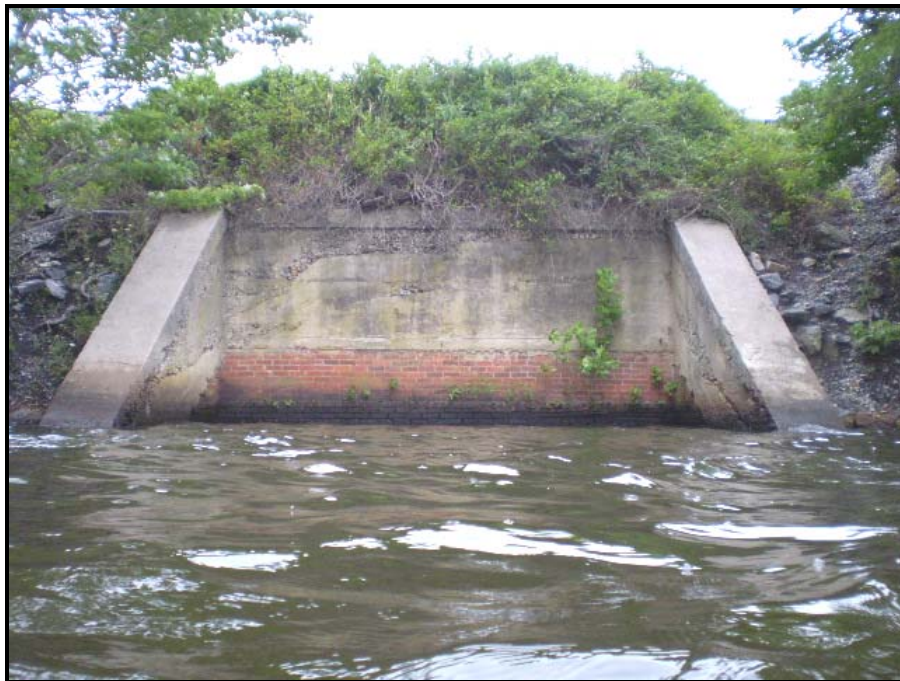
Photo 2
South (Downstream) Headwall

SOUTH HEADWALL CONDITION RATING IS 6 - SATISFACTORY.
 SOUTH WINGWALLS' CONDITION RATING IS 2 - CRITICAL.

- ① HONEYCOMBING UP TO 4" DEEP ON INSIDE FACE OF WINGWALLS AND UP TO 6" DEEP ON OUTSIDE FACE OF WINGWALLS ALONG POUR JOINTS. CONCRETE CAN BE REMOVED BY HAND. CONCRETE PORTION OF WINGWALLS WAS BUILT TO OVERHANG THE BRICK MASONRY ON THE INSIDE FACE OF THE WINGWALLS.
- ② 100% LOSS OF MORTAR IN A 1' HIGH BAND AT THE HIGH WATERLINE.
- ③ LESS THAN 5% OF 3X10 LONGITUDINAL TIMBER PLANKS REMAIN INSIDE OF THE CULVERT.
- ④ LARGE PILE OF LOOSE 3X10 TIMBER PLANKS FROM TIMBER DECKING INSIDE OF CULVERT.
- ⑤ VERTICAL TIMBER SHEETING AT SOUTH END OF TIMBER SUBSTRUCTURE IS MOSTLY GONE. TIMBER SUBSTRUCTURE COULD NOT BE ACCESSED DUE TO TIMBER DEBRIS.
- ⑥ HONEYCOMBING UP TO 2" DEEP ALONG POUR JOINTS. CONCRETE CAN BE REMOVED BY HAND.

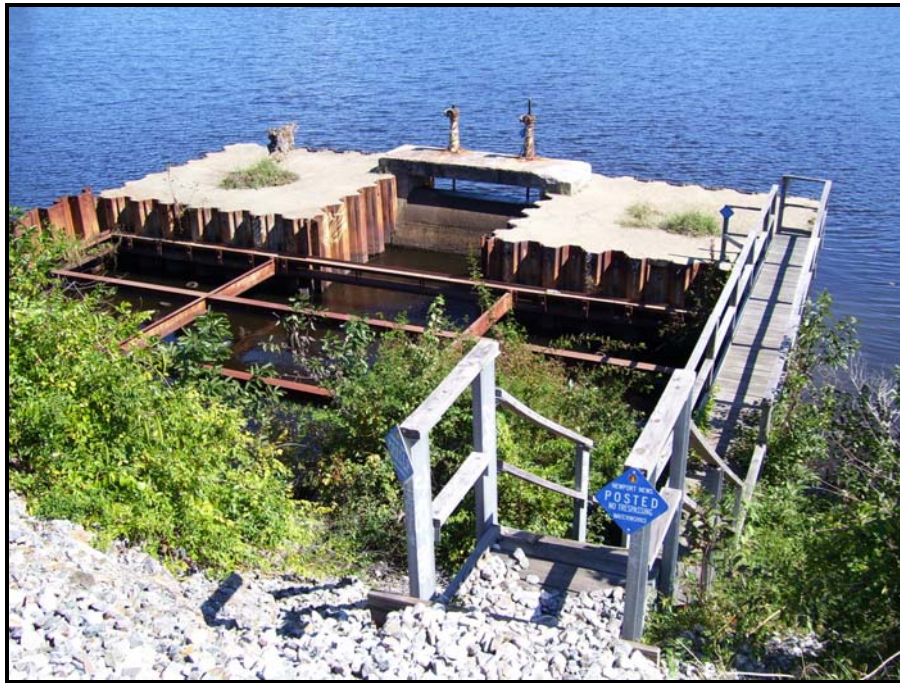
Photo 5
South Elevation of Weir (Looking Northwest)

The weir is in satisfactory condition. The outside face of the steel sheetpile weir walls have up to 50% section loss throughout due to corrosion. The inside face of the steel sheetpile weir walls have a 1' high band of 60-70% section loss at the high waterline with some near perforations. There is up to 50% section loss throughout the remaining surfaces of the inside faces of the steel sheetpile walls. The downstream face of the concrete weir wall has a band of heavy scale with exposed large aggregate from 1' above the high waterline to the waterline. The concrete invert and apron of the weir structure were roughly poured.
